2025 Annual Inspection Report Unit 3A/B Impoundments

For Compliance with the EPA Coal
Combustion Residuals (CCR) Rule
40 CFR §257.83(b)

Former J.B. Sims Generating Station

July 29, 2025

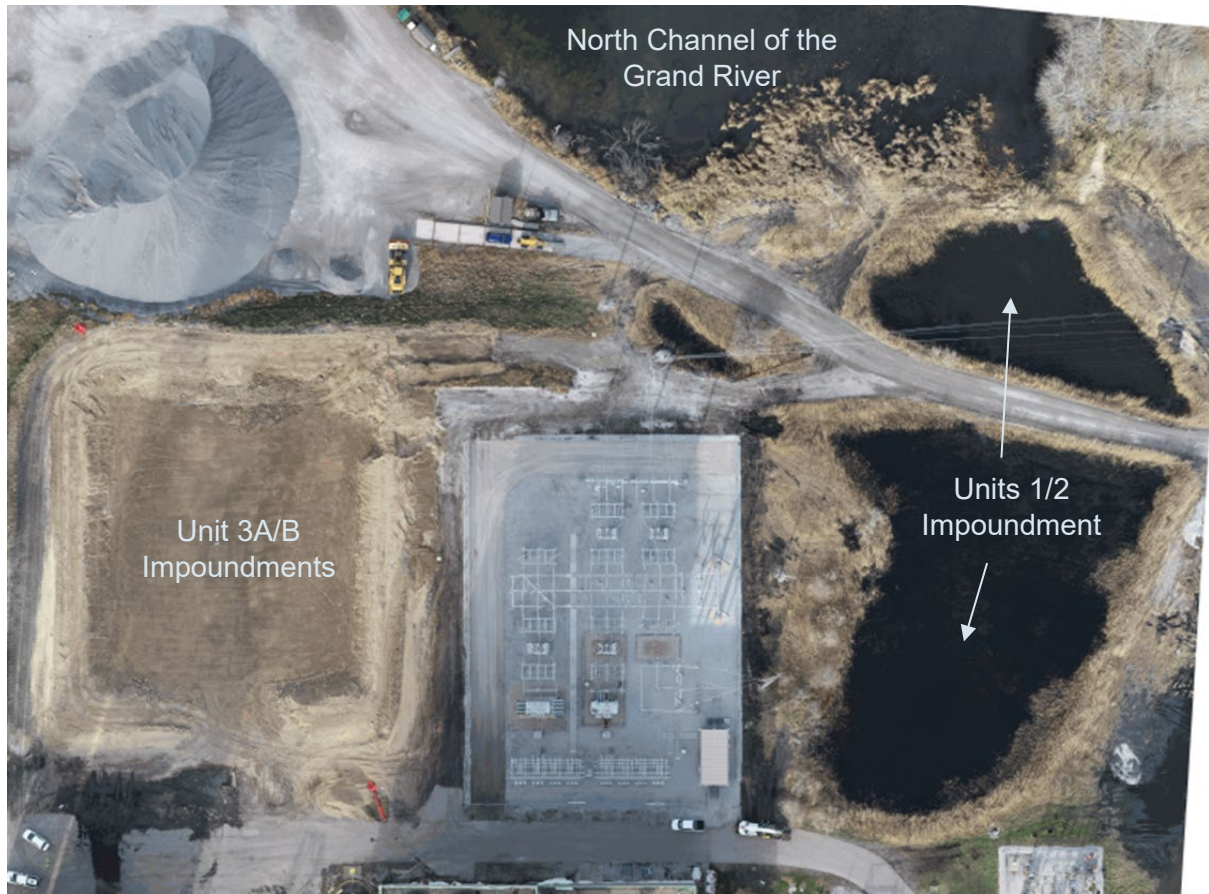
Figure 2. Site Configuration

The former Unit 3A/B Impoundments originally consisted of two adjacent impoundments, consisting of engineered, clay-lined, above-ground ponds that allegedly were built over historically deposited ash from Boiler Units 1 & 2 (HDR has not confirmed whether ash actually is present below the Impoundments). The former impoundments were separated from each other by a 10-foot-wide earthen dike and had dimensions of 175 to 190 feet long by 71 to 80 feet wide with an approximate surface area of 0.2 and 0.3 acres for the east and west ponds, respectively. Although the former coal-fired power generation facility ceased operations in February 2020, the Site continued to use the impoundments to clean out the hoppers, vessels, etc. prior to demolition of the buildings. In July 2020, following the clean out procedures, the Site ceased CCR waste disposal in the Unit 3A/B Impoundments. CCR materials were removed in December 2020, with the center embankment separating the ponds being removed, and thus a single inactive impoundment remains. The berm surrounding the pond remains intact, except for the south side of the berm that was removed as part of the excavation. The berms surrounding the east and west sides of the former impoundment range in elevation from 590.8 feet to 593.3 feet and 591.4 feet to 592.5 feet, respectively. The north berm ranges in elevation from 593.0 feet to 594.9 feet. The south remaining berm ranges in elevation from 585.5 feet to 592.2 feet.

The Site is a former coal-fired power generation facility which ceased operations in February 2020. CCR generated at the former generating station were stored in inactive Units 1/2 Impoundment and the excavated Unit 3A/B Impoundments. The inactive Units 1/2 Impoundment are situated in the northeast of the facility and the inactive Unit 3A/B Impoundments are located at the northwest end of the plant property as shown on Figure 2.
