2026 Annual Inspection Report Unit 3A/B Impoundments

For Compliance with the EPA Coal
Combustion Residuals (CCR) Rule
40 CFR §257.83(b)

Former J.B. Sims Generating Station

June 24, 2026

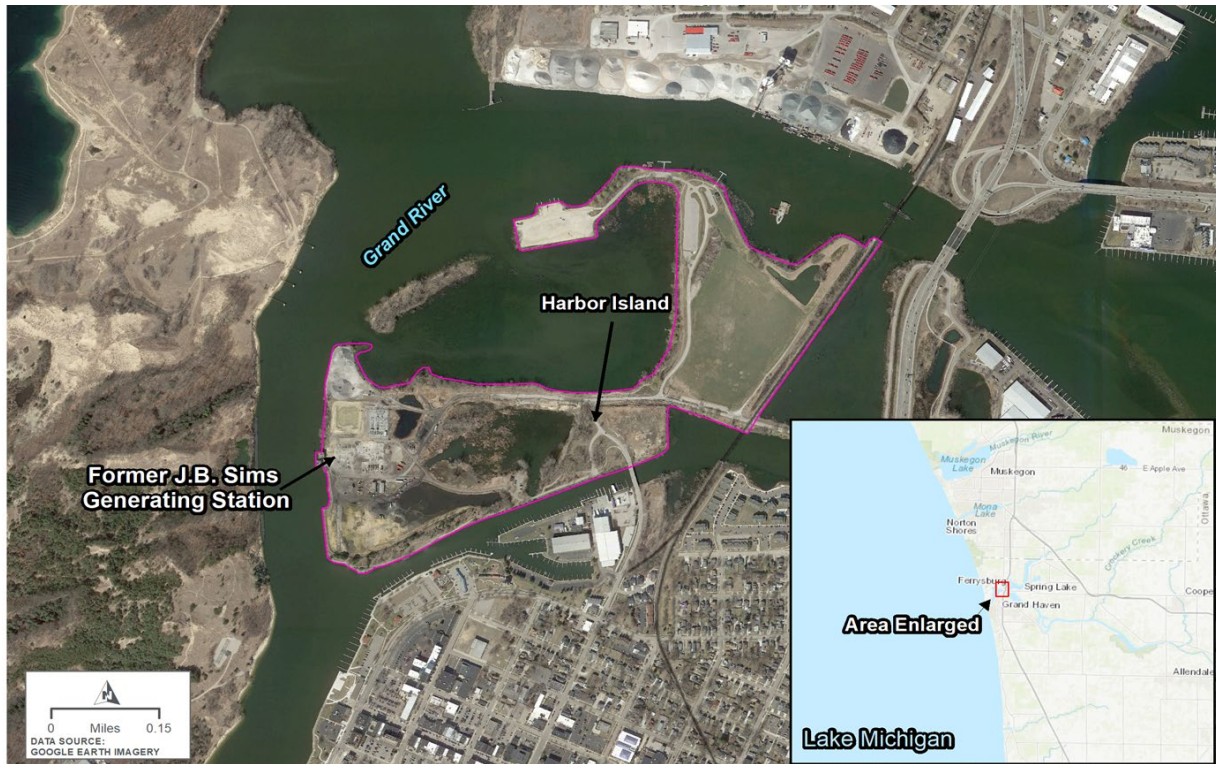
Figure 1. Site Vicinity Map

The former J.B. Sims Generating Station (Facility or Site) was a coal-fired power generation facility operated by Grand Haven Board of Light & Power (GHBLP) that ceased operations in February 2020. The facility is located at 1231 North 3rd Street, on Harbor Island, in Grand Haven, Michigan. The latitude and longitude of the Site are approximately 43.071179 N and 86.234551 W. The Site is located north of downtown Grand Haven, adjacent to the Grand River, as shown in the vicinity map, Figure 1.
